Subject: Asbestos Re-inspection Report

ASBESTOS REINSPECTION

SOCIAL SECURITY ADMINISTRATION
BURLINGTON FIELD OFFICE
3012 DIVISION STREET
BURLINGTON, IA 52601

JUNE 25, 2009

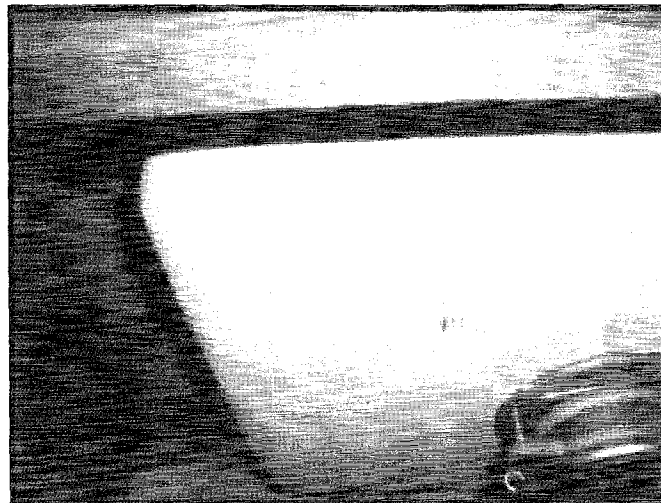
Photograph 2

The sink undercoating tested positive for asbestos. The sink undercoating contains 5-10% chrysotile asbestos. The sink undercoating is found in the multi-purpose room. There is approximately 4 square feet of material. This sink undercoating is considered non-friable, and in good condition. The sink undercoating is located in low use area of the facility and presents a low health hazard potential to building occupants due to a minimal potential for disturbance and fiber release. The assigned risk assessment codes (RAC) and response recommendations for the asbestos-containing materials are derived from established SSA criteria. This building material is assigned a risk assessment code of 4 because it is a non-friable material not requiring repair. This asbestos-containing joint compound should be placed in an Operations and Maintenance program until renovation activities require removal or laboratory analysis determines this material to be non-asbestos-containing.

**Previously Sampled (September 2003)
SINK UNDERCOATING**

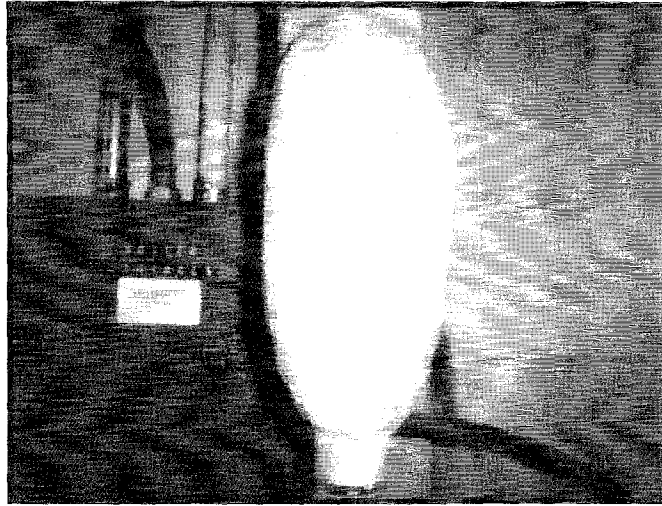
Photograph 3

The gray thermal system insulation (elbows) tested positive for asbestos. The thermal system insulation contains 2-4% chrysotile asbestos. The thermal system insulation is found in the mechanical room. There is approximately 12 linear feet of material. This thermal system insulation is considered non-friable, and in good condition. The thermal system insulation is located in low use area of the facility and presents a low health hazard potential to building occupants due to a minimal potential for disturbance and fiber release. The assigned risk assessment codes (RAC) and response recommendations for the asbestos-containing materials are derived from established SSA criteria. This building material is assigned a risk assessment code of 4 because it is a non-friable material not requiring repair. This asbestos-containing joint compound should be placed in an Operations and Maintenance program until renovation activities require removal or laboratory analysis determines this material to be non-asbestos-containing.

Sample No. 07-0699-A001B-A003B
THERMAL SYSTEM INSULATION-ELBOWS, Gray

07-0699-A001B: Yes				
Insulation: gray, heterogeneous, friable, fibrous		Chrysotile 2-4	Cellulose 20 Fibrous glass 10	2-4

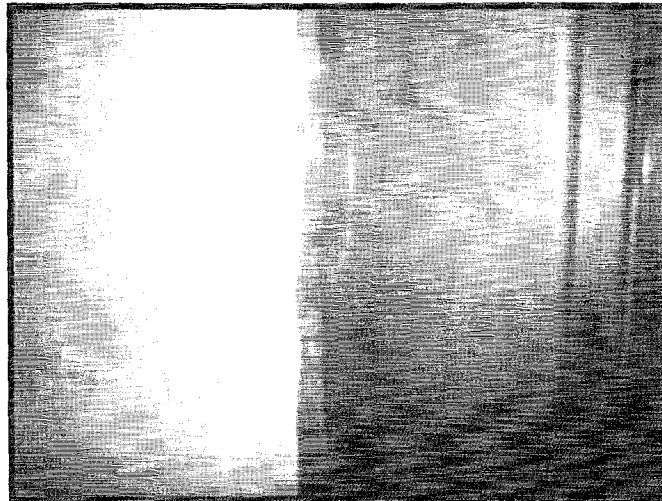
Photograph 4

The white caulking tested positive for asbestos. The caulking contains 3-5% chrysotile asbestos. The caulking is found in the mechanical room, janitorial room, ADP room, storage room, employee women's restroom, and employee entrance area. There is approximately 6 square feet of material. This caulking is considered non-friable, and in good condition. The caulking is located in high use areas of the facility, but presents a low health hazard potential to building occupants due to a minimal potential for disturbance and fiber release. The assigned risk assessment codes (RAC) and response recommendations for the asbestos-containing materials are derived from established SSA criteria. This building material is assigned a risk assessment code of 4 because it is a non-friable material not requiring repair. This asbestos-containing joint compound should be placed in an Operations and Maintenance program until renovation activities require removal or laboratory analysis determines this material to be non-asbestos-containing.

Sample No. 07-0699-A004B-A006B
CAULKING, White

07-0699-A004B: Yes				
Caulk: white, homogeneous, nonfriable, nonfibrous		Chrysotile 3-5	None	3-5

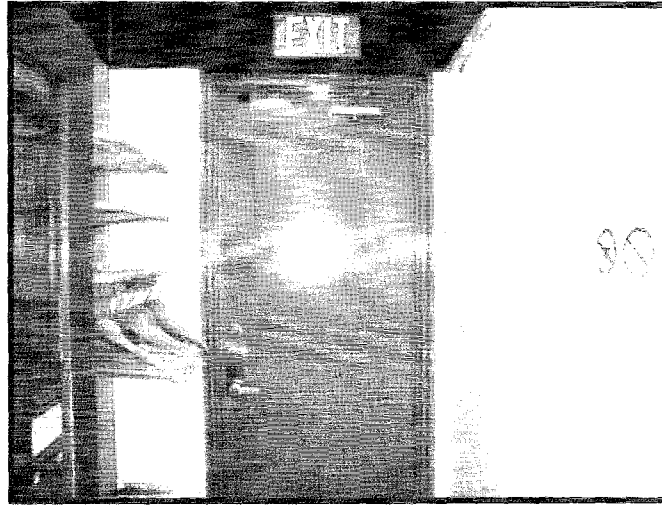
Photograph 5

The fire doors were identified as assumed asbestos containing. The fire doors were found in the mechanical room, janitorial room, employee entrance area, and staff men's restroom. During future renovations, these fire doors should be treated as asbestos containing unless further testing proves otherwise. This fire doors are considered non-friable and in good condition. The fire doors are located in high use areas of the facility, but present a low health hazard potential to building occupants due to a minimal potential for disturbance and fiber

**Not Sampled, Assumed to be Asbestos-containing
FIRE DOORS**
